# *Burnt Clay Products in Fire and Earthquake*

*Issued by the Manufacturers of Burnt Clay Products*  
***Brick Construction Association***  
*707 Lankershim Building, Los Angeles, Cal.*

## *The San Francisco Calamity*

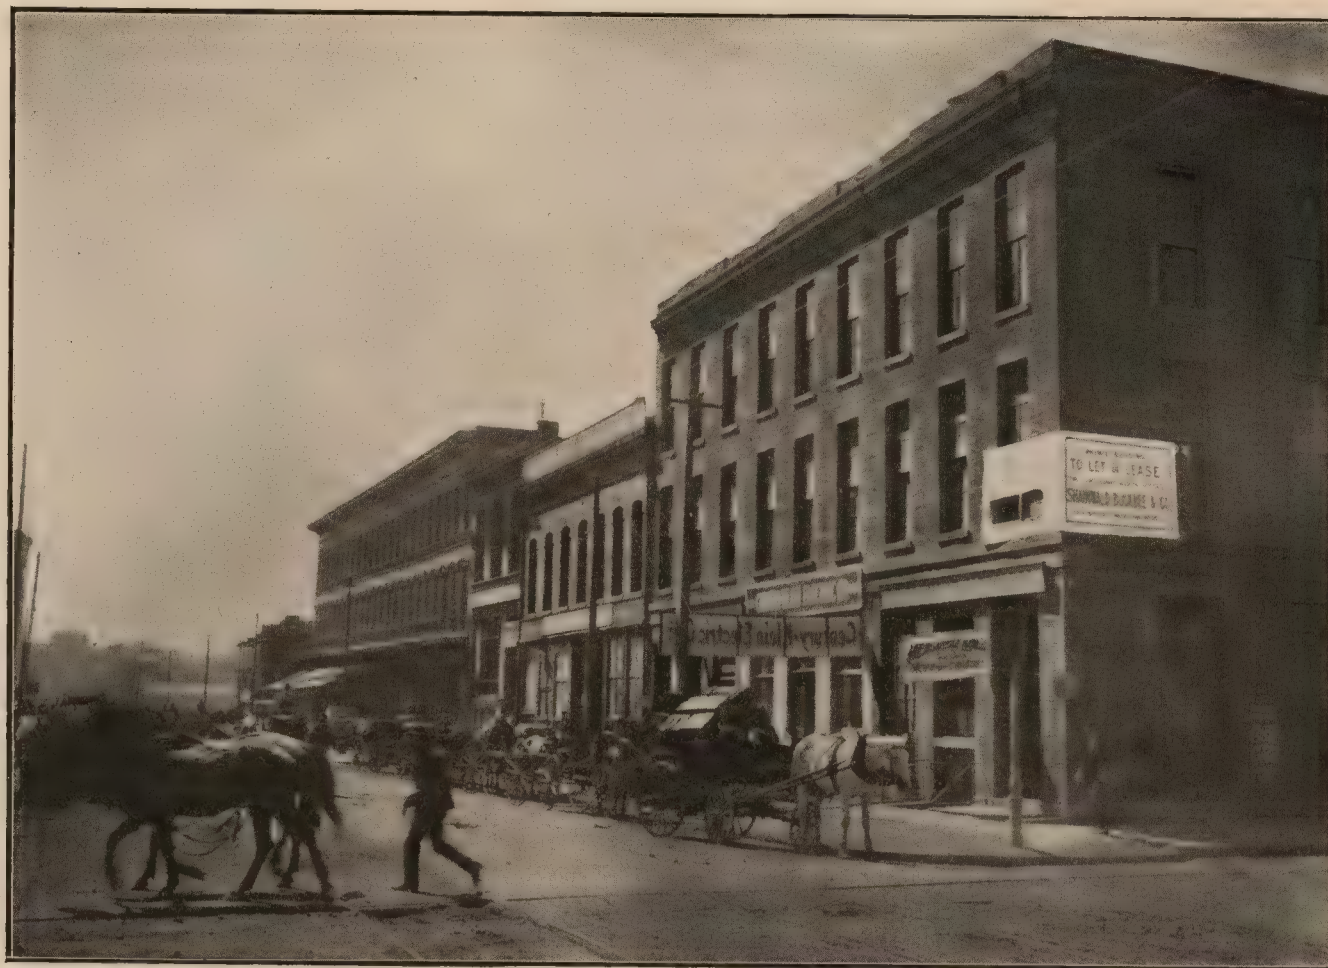
*Jackson Street, between Sansome and Montgomery*

The buildings are of the same style of construction as those shown in the preceding picture. They received the full force of the shocks, but escaped the ravages of fire. Note perfect condition.

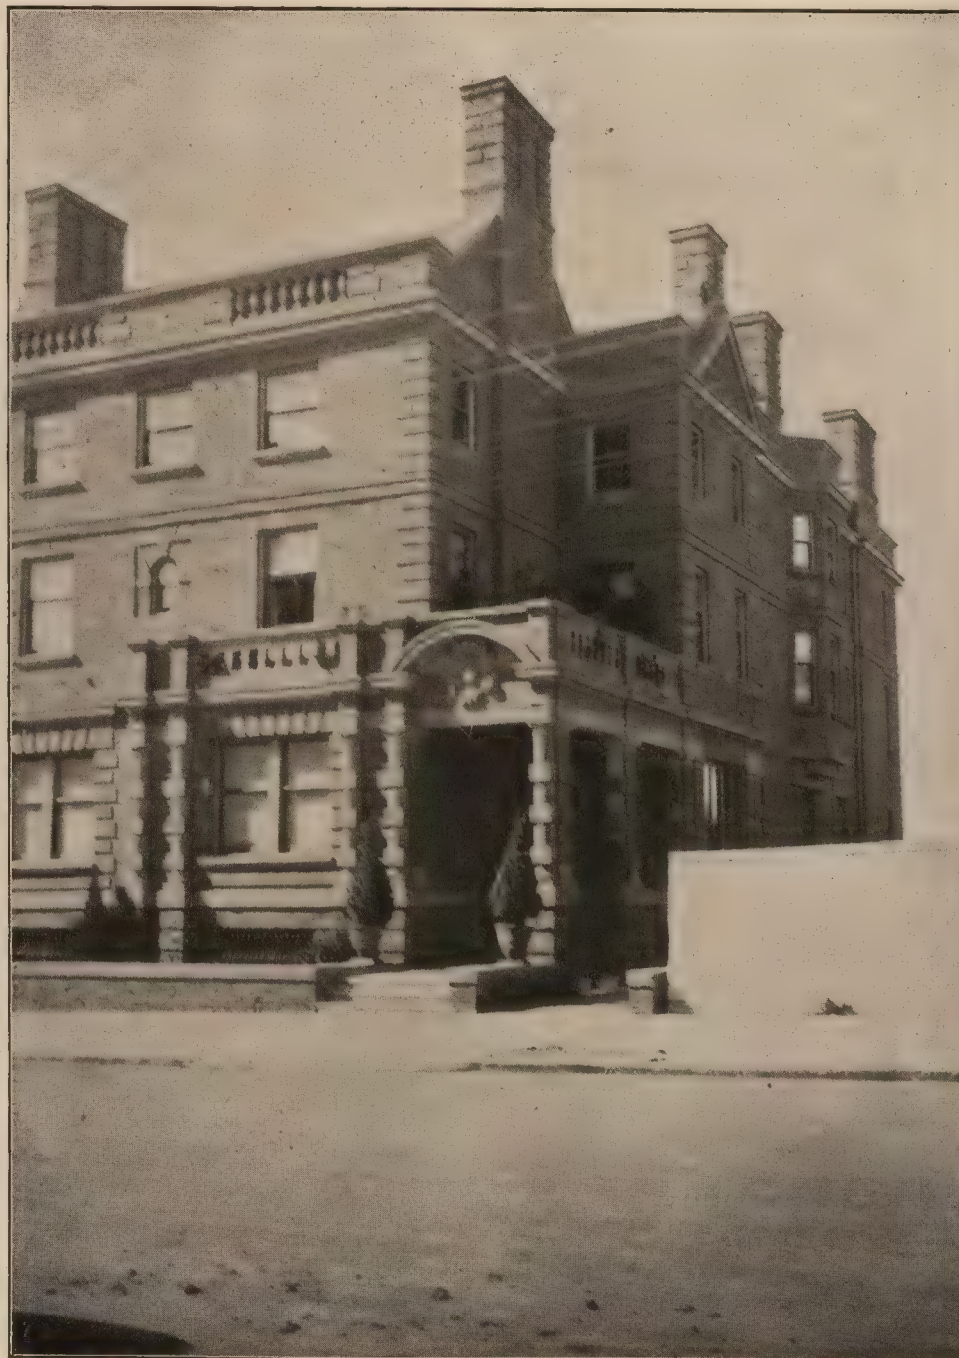
*Brick Residence, San Francisco*

After earthquake and fire. Results of good brick construction. No damage was done to brick walls.

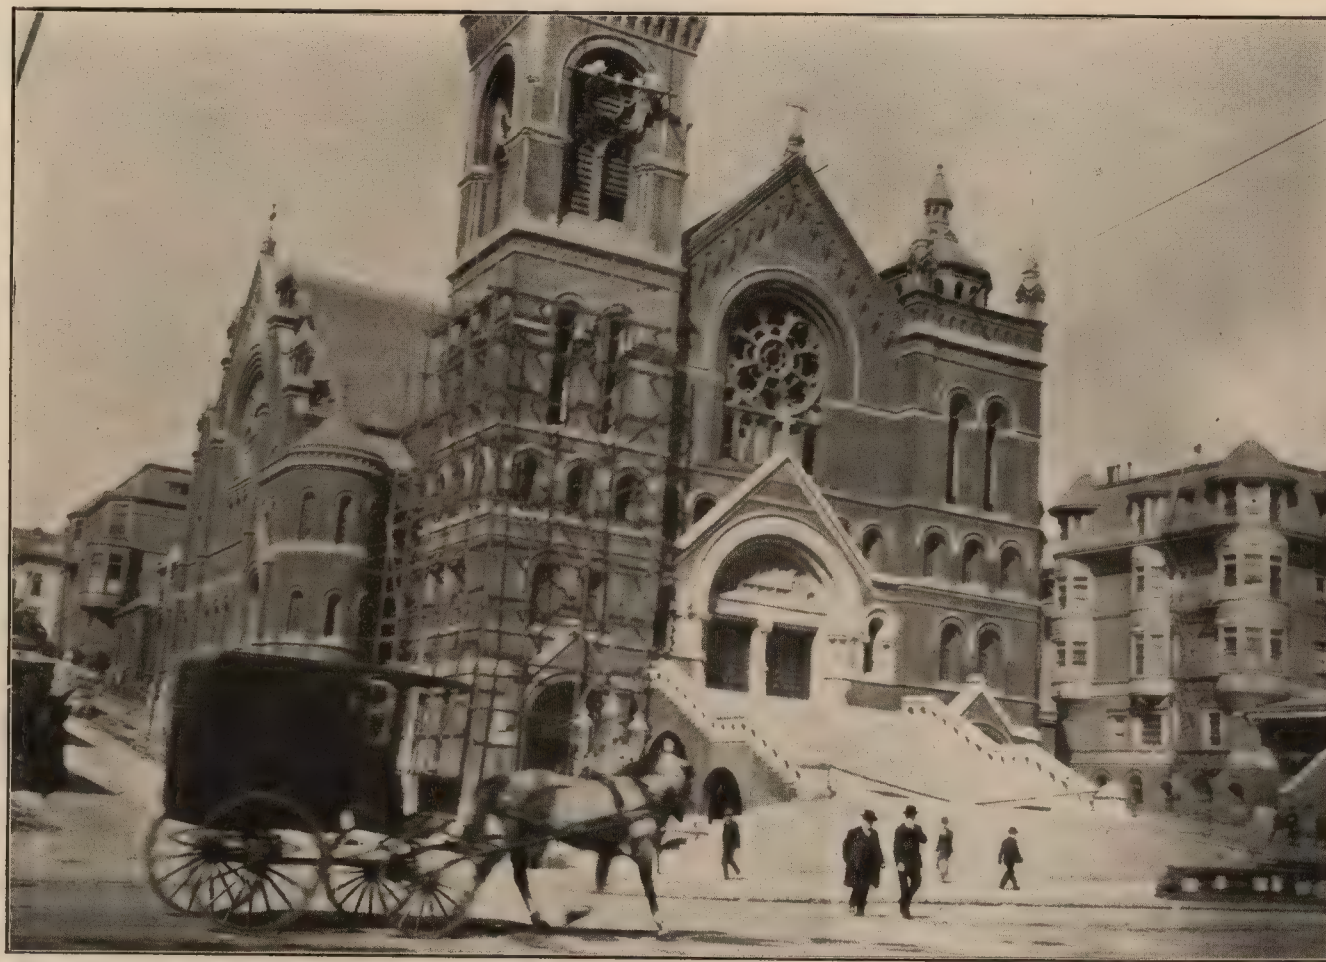
*Cathedral at Van Ness Ave. and O'Farrel St. Brick Building*

Practically uninjured by the earthquake; a monument to the good judgment of its builders. The building caught fire in the tower. The only effect of the quake was a crack over a window.

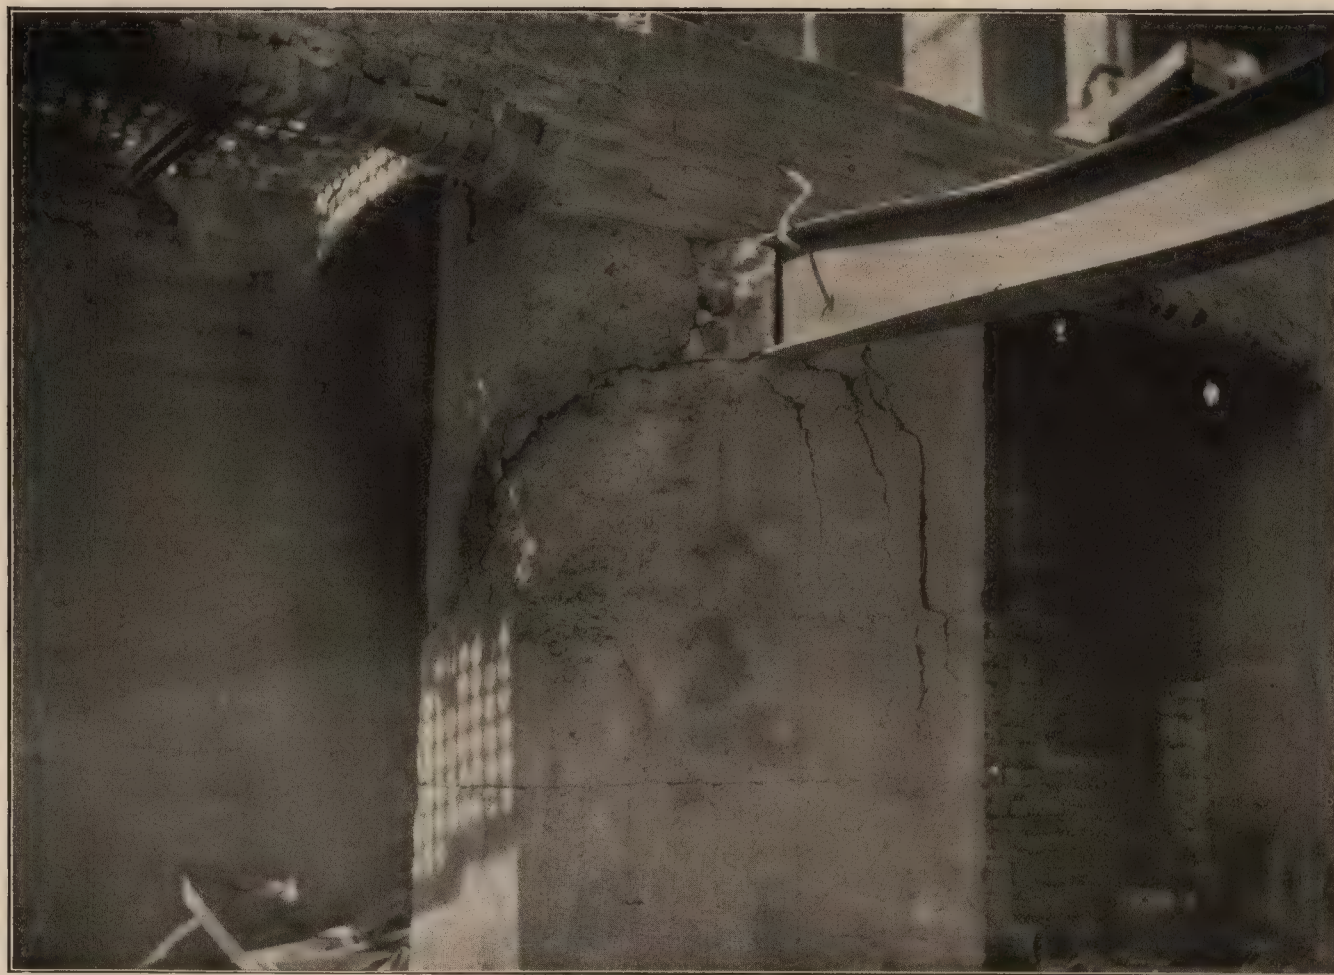
*Concrete Pier*

This pier is typical of many others, showing the manner in which concrete breaks and spalls off. It acts very similarly to granite, under fire.

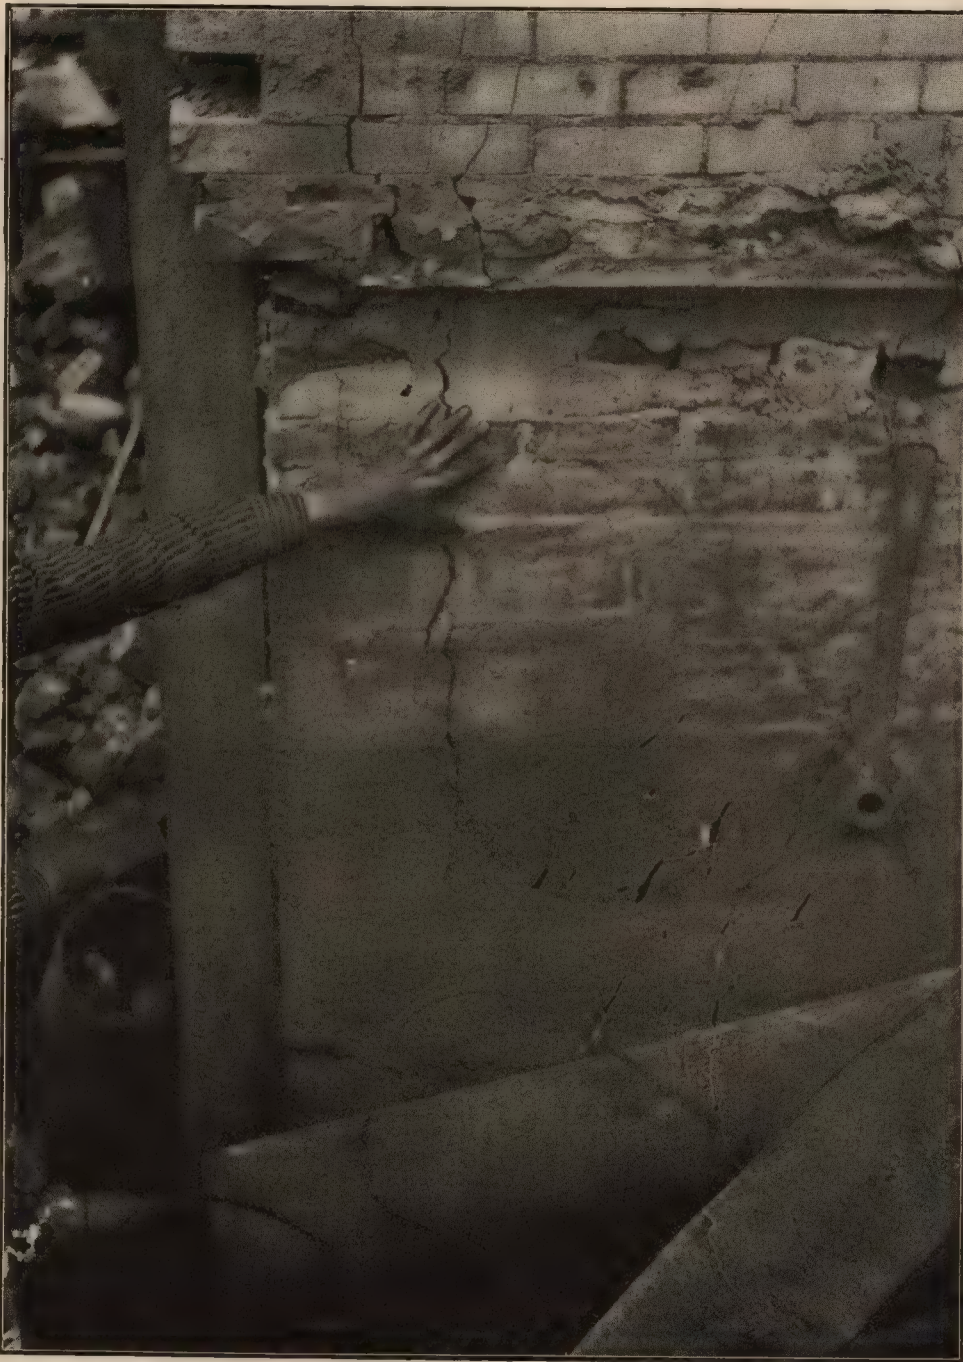
### *Monadnock Building*

Showing excellent condition after earthquake and fire.

Note manner in which the granite cap has spalled off through the action of fire while brick are unharmed.

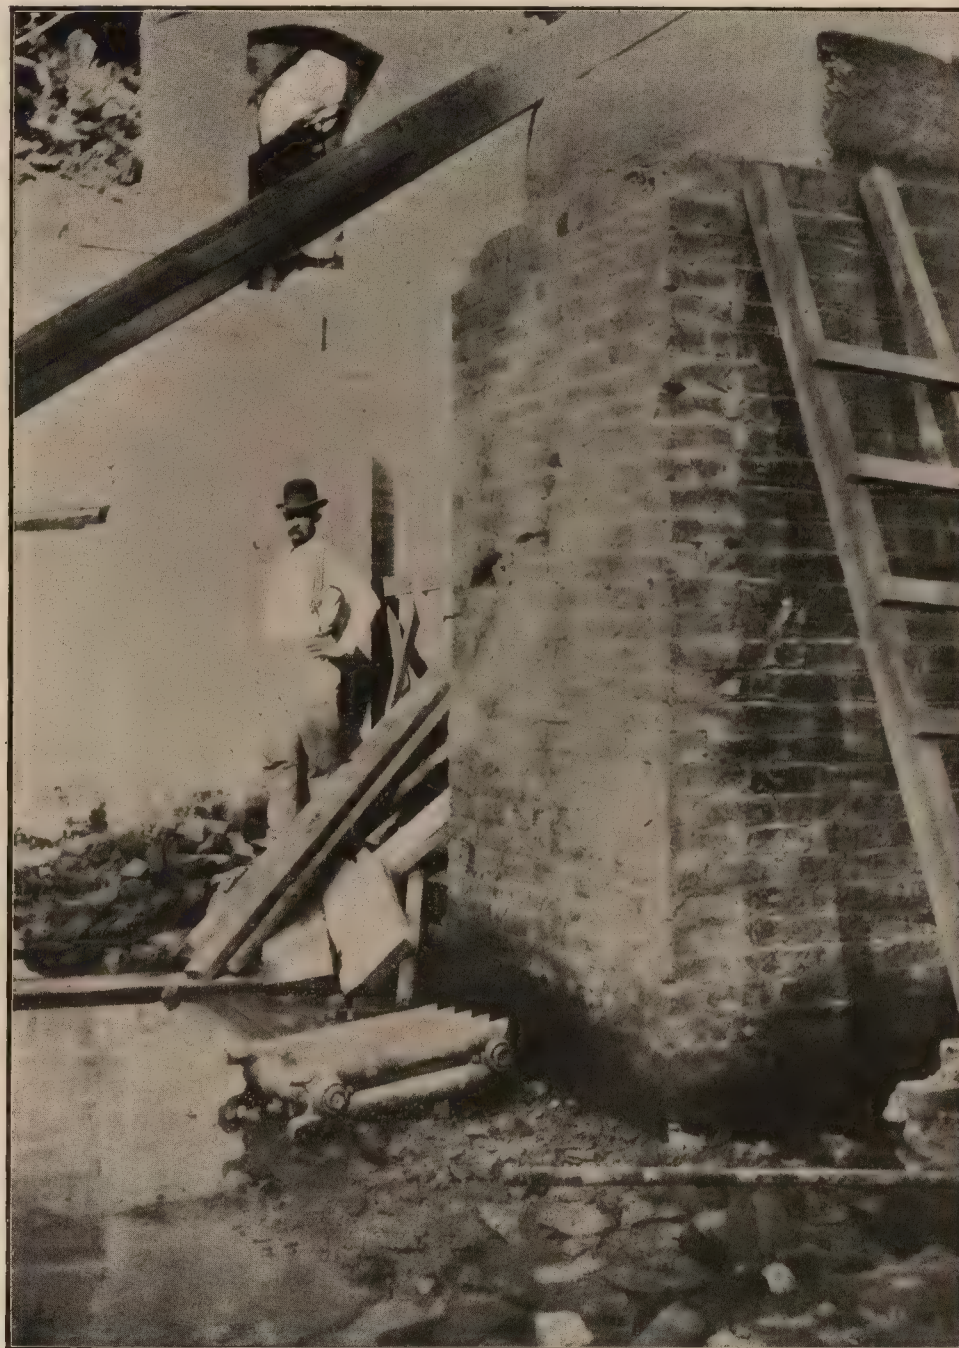
### *Concrete Piers*

Same locality and under same conditions as brick piers shown on preceding page. Note spalling, also cracks. The life, or strength, of the concrete was destroyed by the action of fire. Large pieces could easily be knocked from the piers.

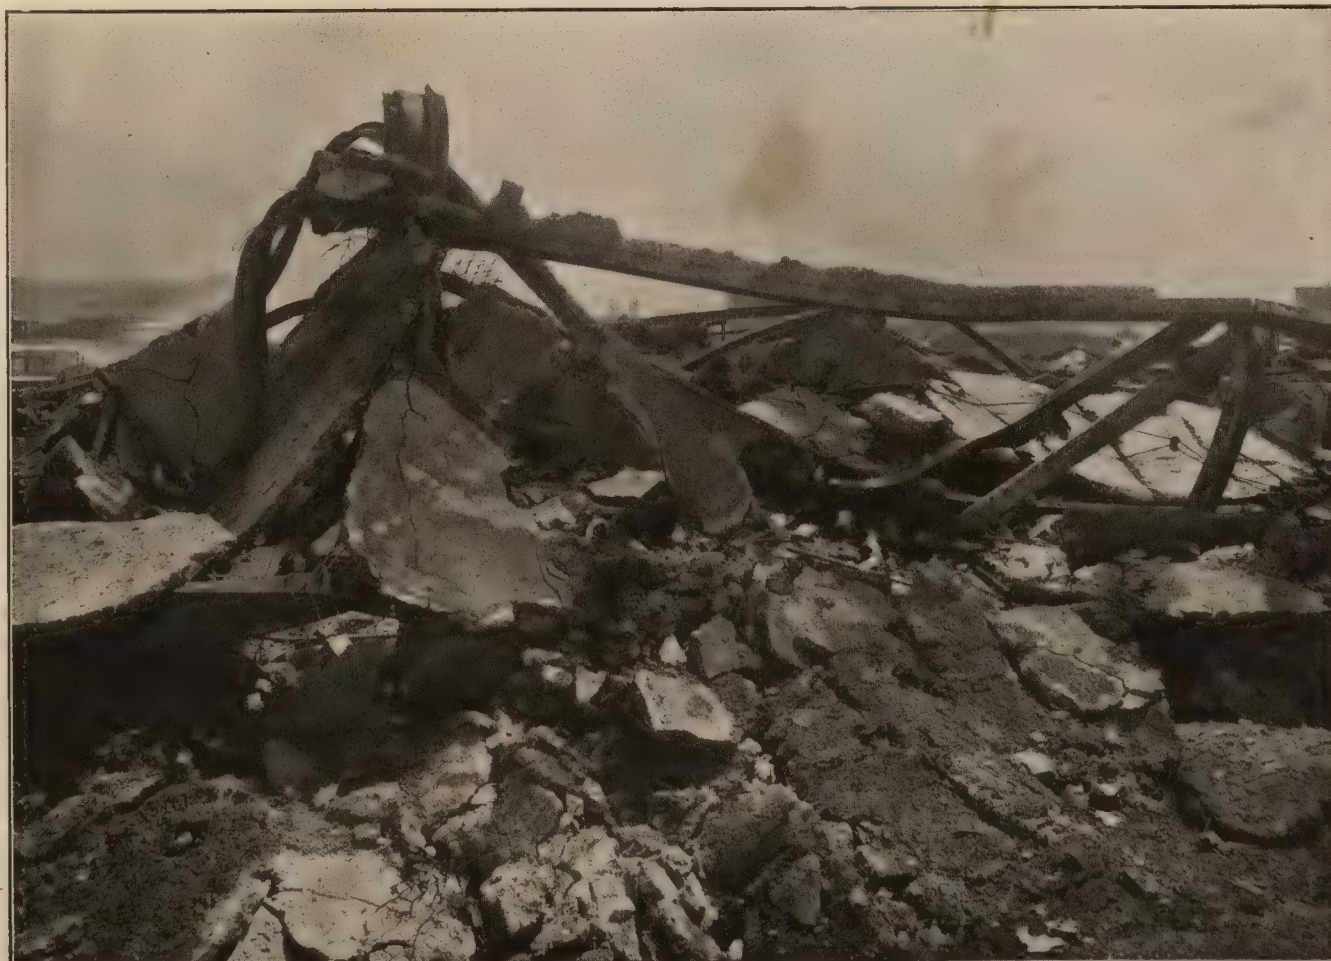
*Concrete Roof, Scott Building*

The concrete shown in this picture collapsed from vibrations of earthquake. It was afterward disintegrated by fire, so that it could easily be crushed into dust.

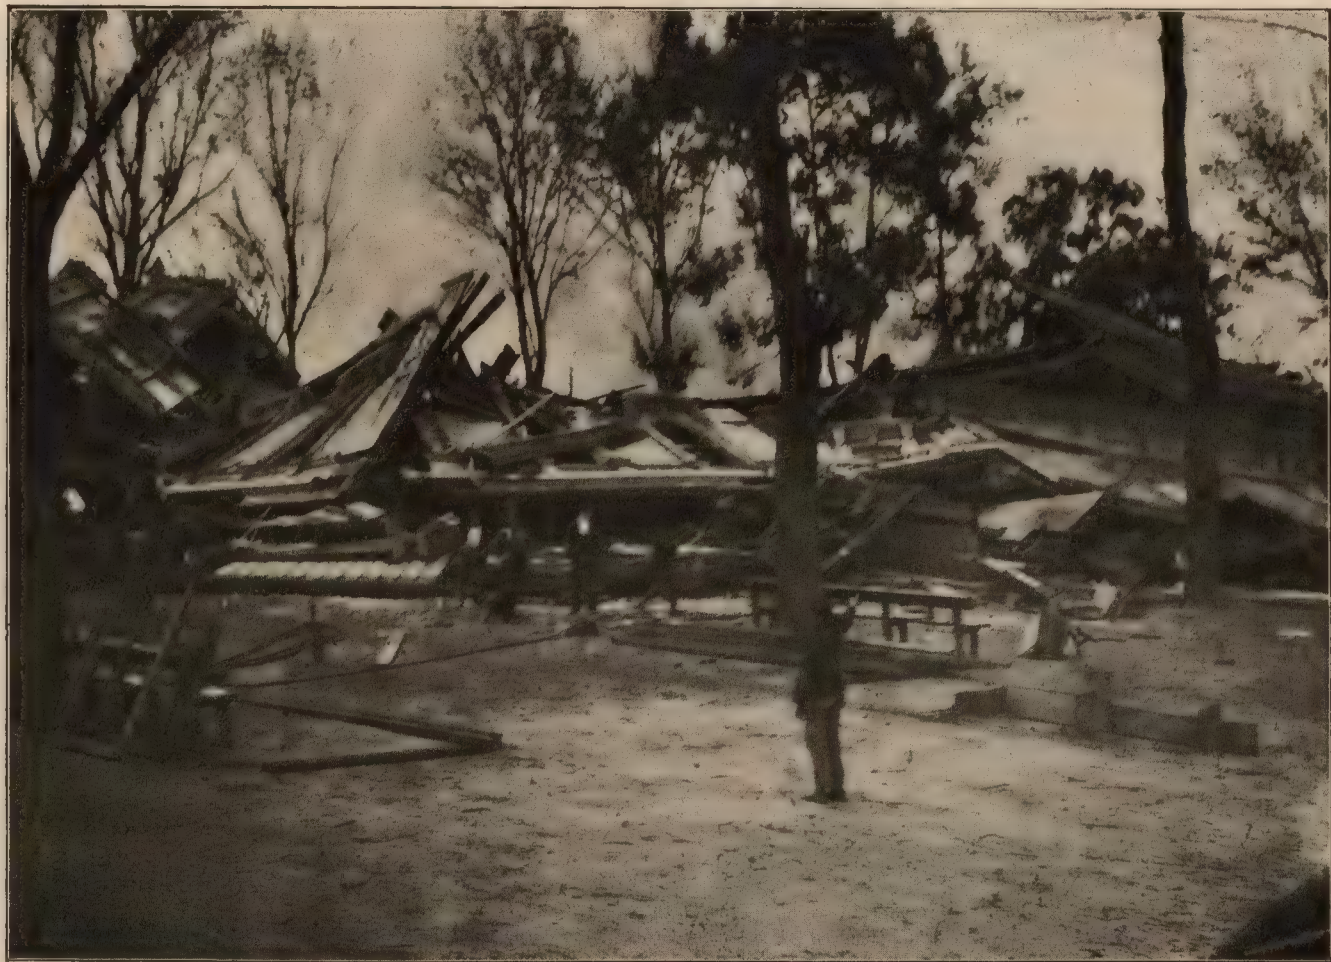
*Grant School, San Jose*

Frame construction. A total collapse.

The earthquake came early in the morning, before the building was occupied. If it had occurred during school hours, hundreds of children probably would have been killed or injured.

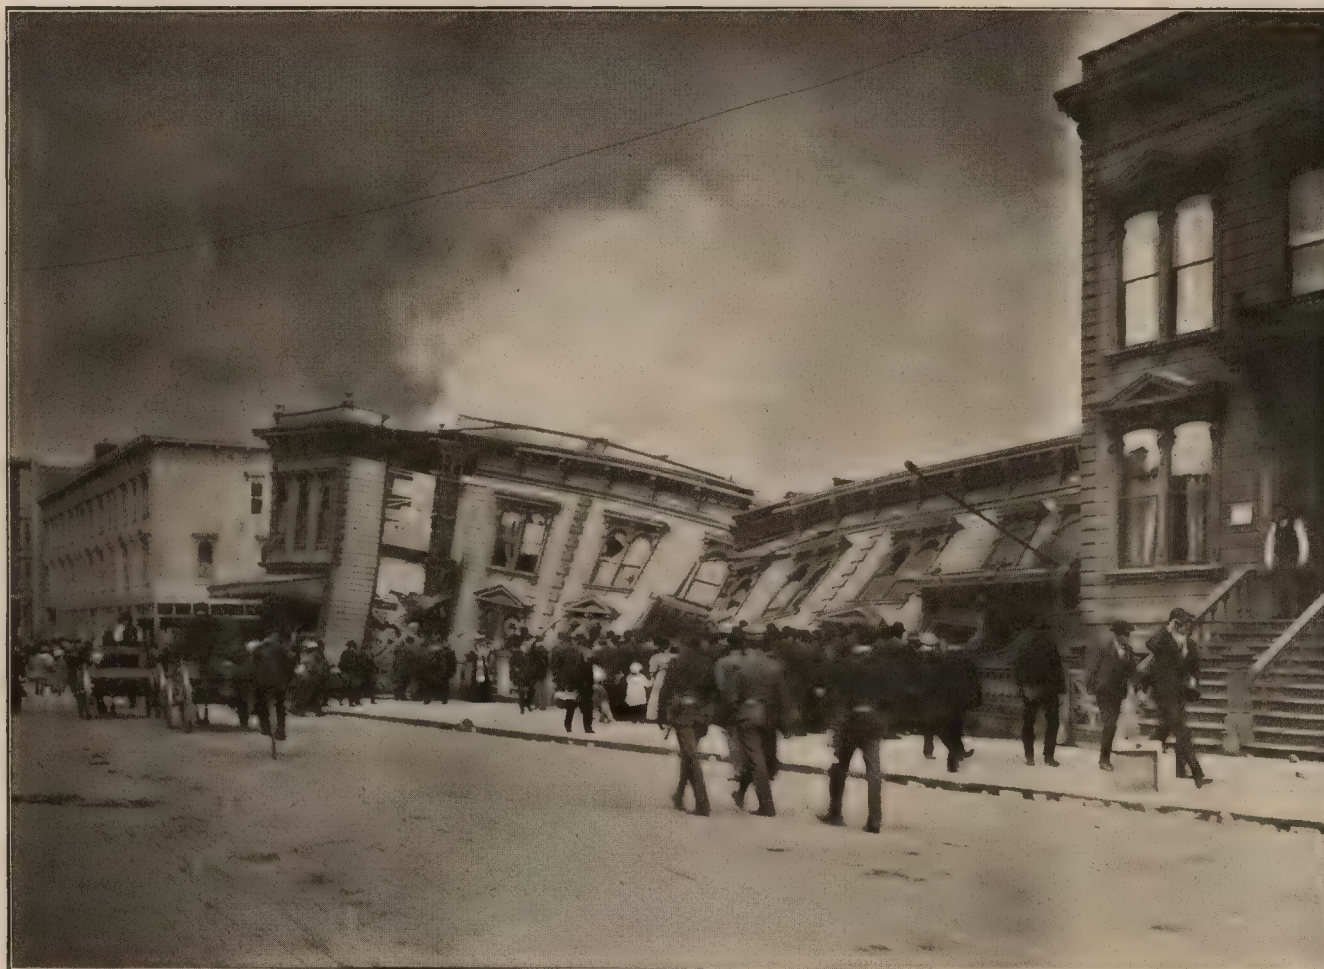
### *Valencia Street, San Francisco*

Recovering the dead and injured from frame buildings. Approximately 95 per cent of the loss of life was due to the collapse of this form of building. Fire, to be seen in the background, a few hours later wiped out the buildings shown.

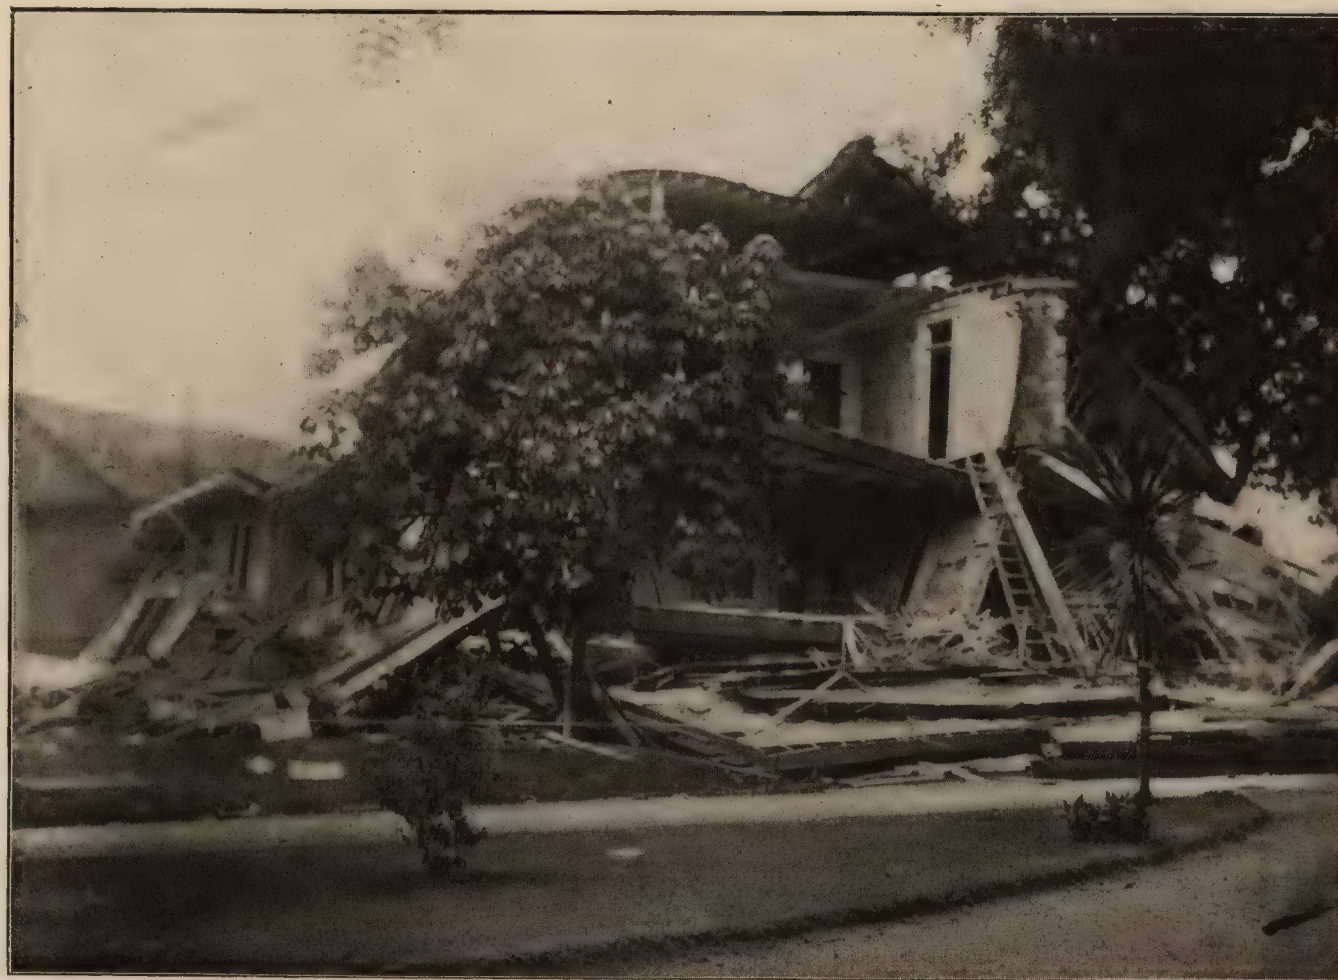
*Frame Collapse*

Hotel Vendome annex, San Jose. This building was erected on a flimsy wooden foundation, and simply fell over when the shock came.

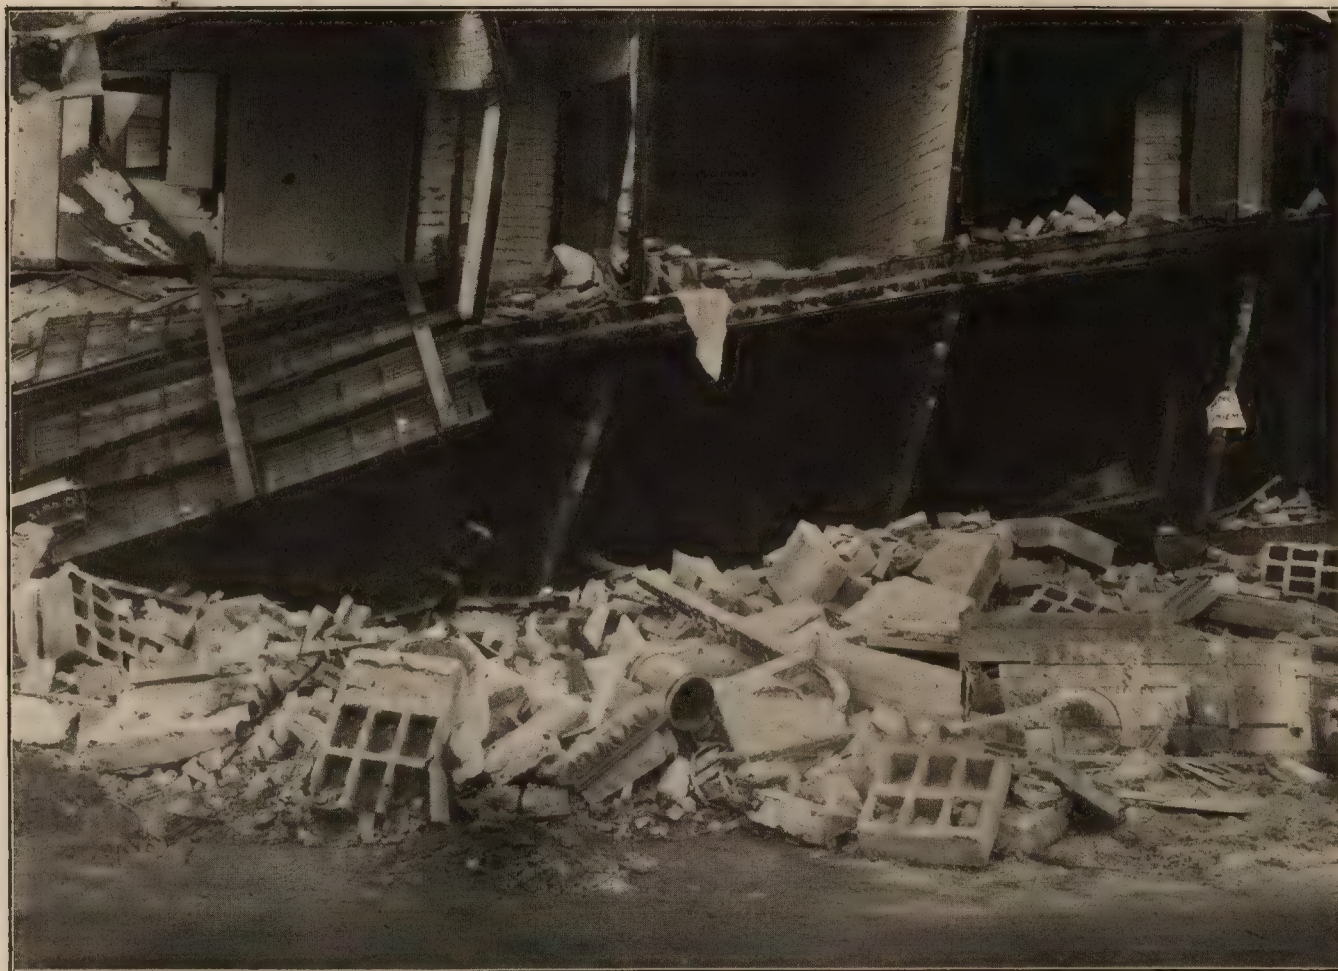
### *Hollow Concrete Blocks*

Two-story hollow-block building in Palo Alto. The entire outer walls of this building, which were constructed of concrete hollow blocks, were leveled to the ground, the blocks themselves being broken into small pieces.

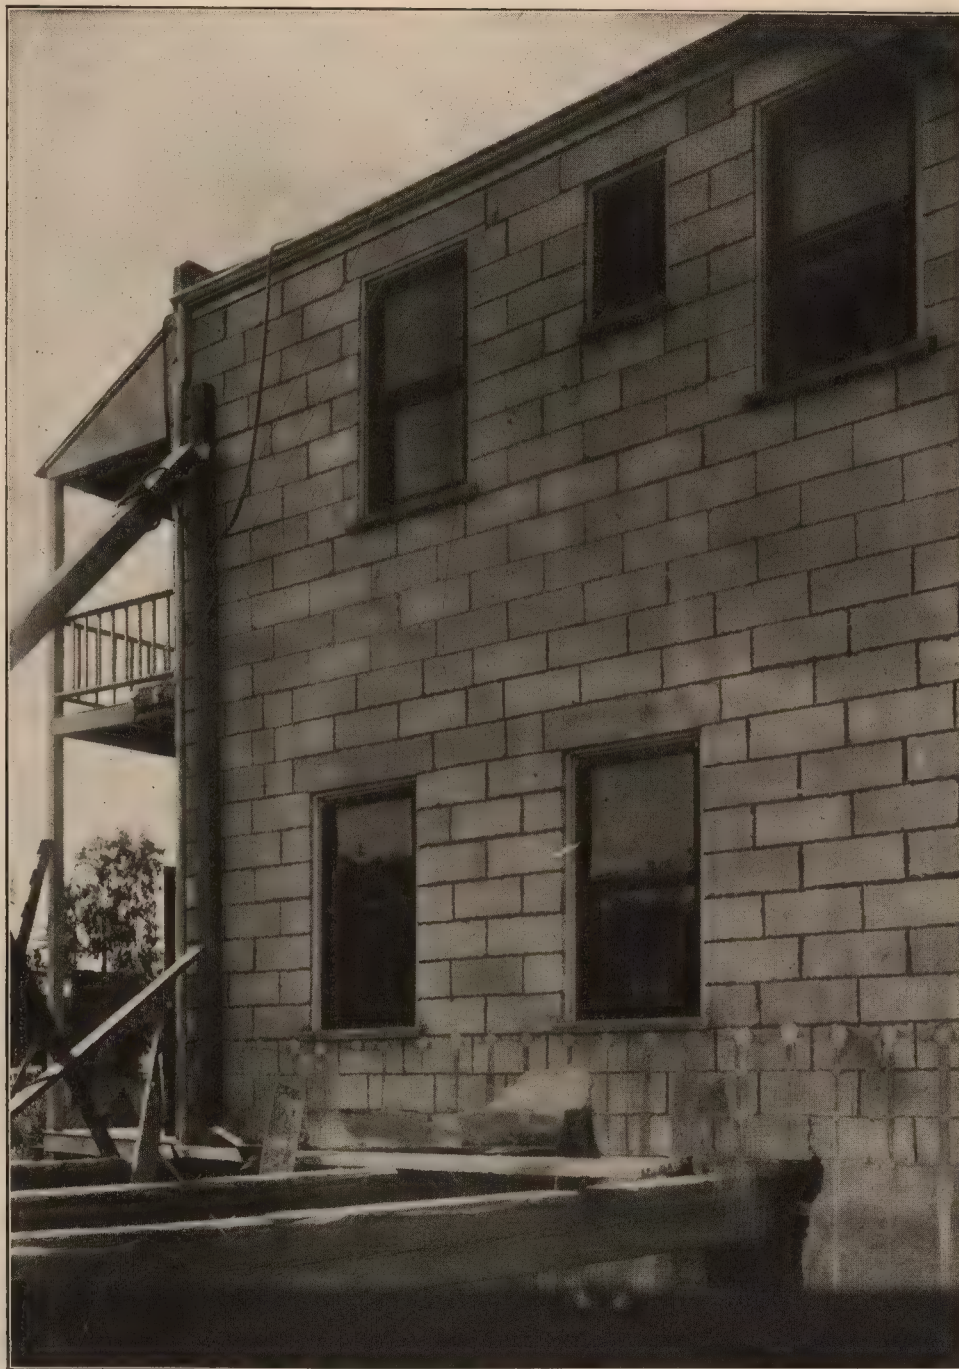
### *Concrete Blocks—an Object Lesson.*

The result in this case was that after the building had been completed and occupied a short time, cracks began to appear in walls and blocks showed signs of crumbling. Efforts were made to repair structure by filling hollow spaces in blocks with cement.

Ultimately building was condemned and torn down. A complete loss to owner.

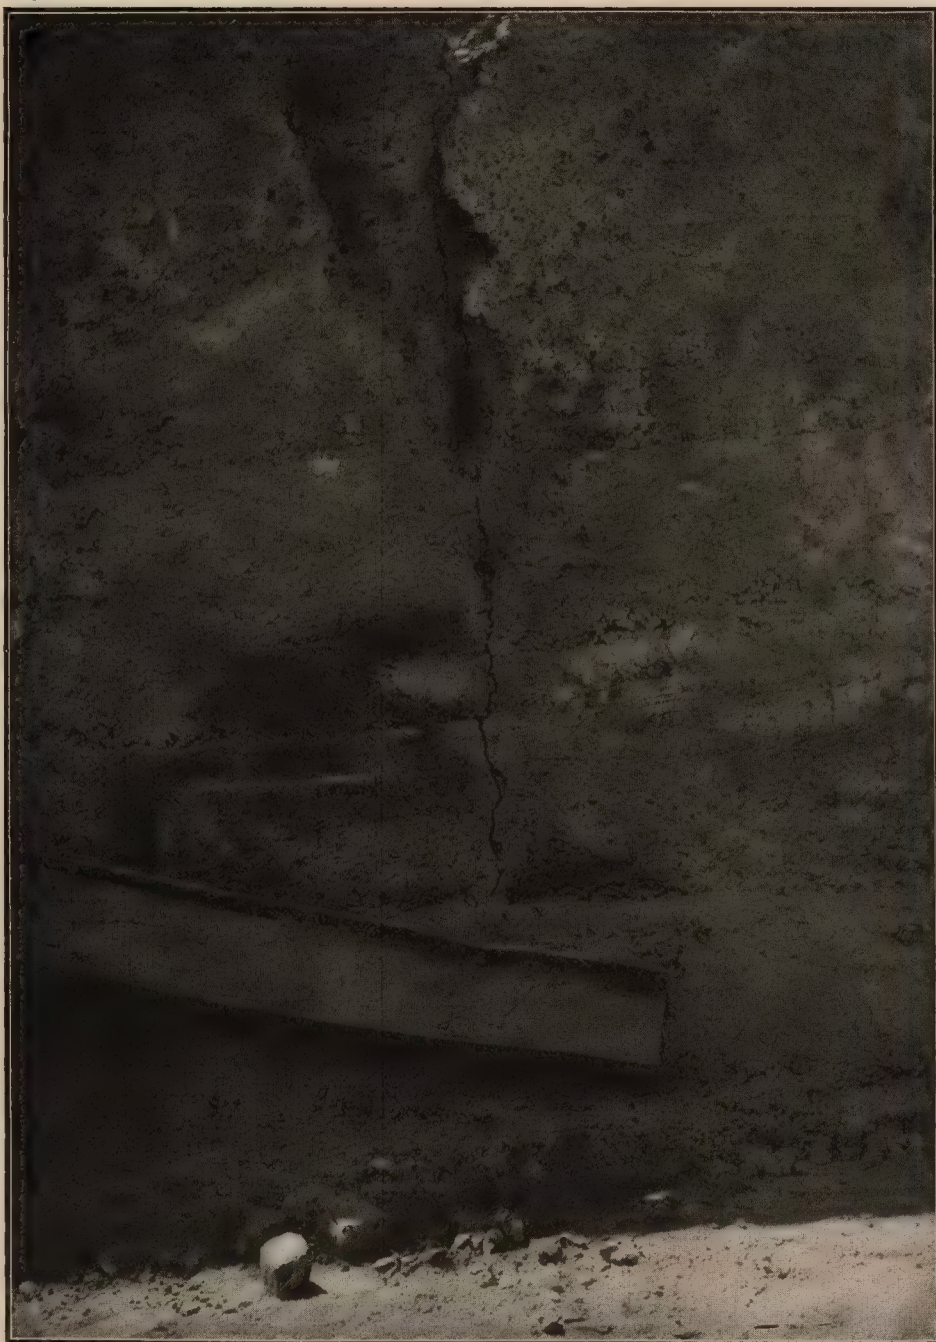
*Dehydrated or Burned Concrete  
in Basement Wall*

Showing typical crack that appeared through  
shrinkage of cement or action of the quake.

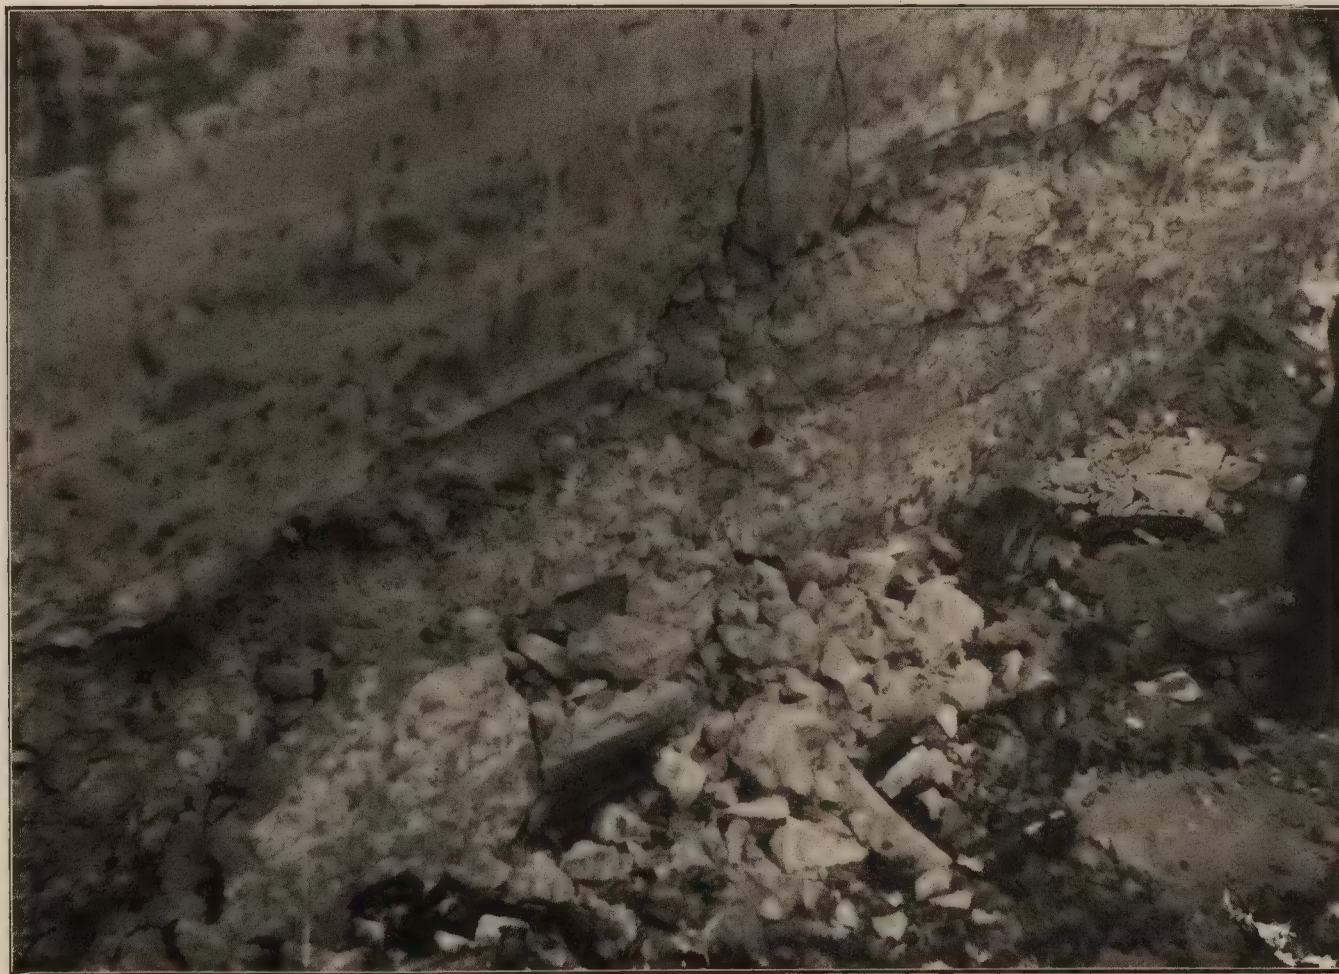
*Effect of Earthquake on Concrete Foundation*

Showing failure of same near bottom. Note large inverted V-shaped piece that had been forced out, causing wall to shift out of plumb. A study of this picture is very important.

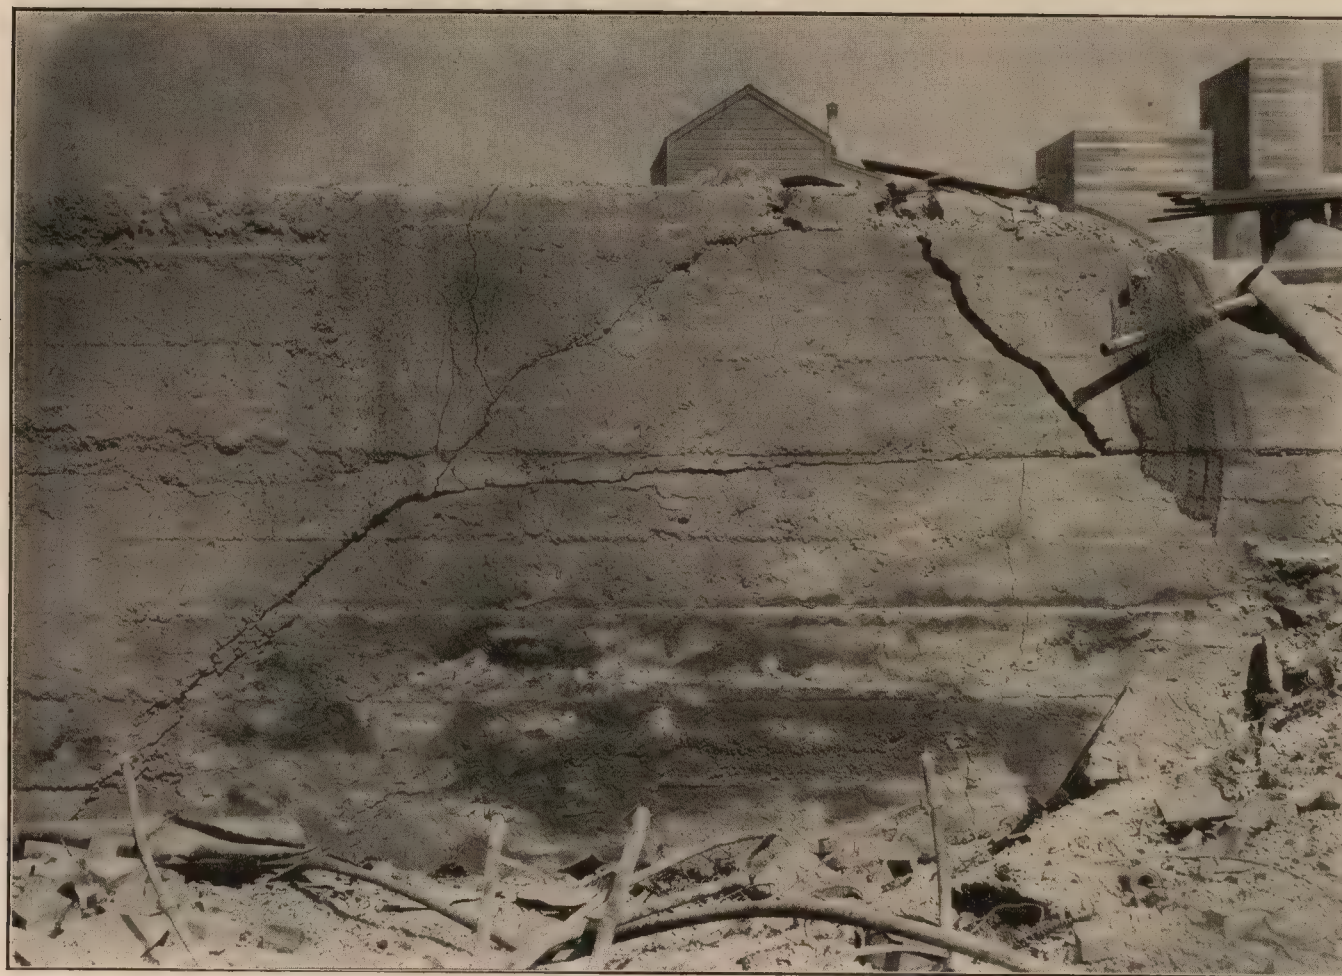
*Concrete Foundation*  
Showing effect of earthquake and fire.

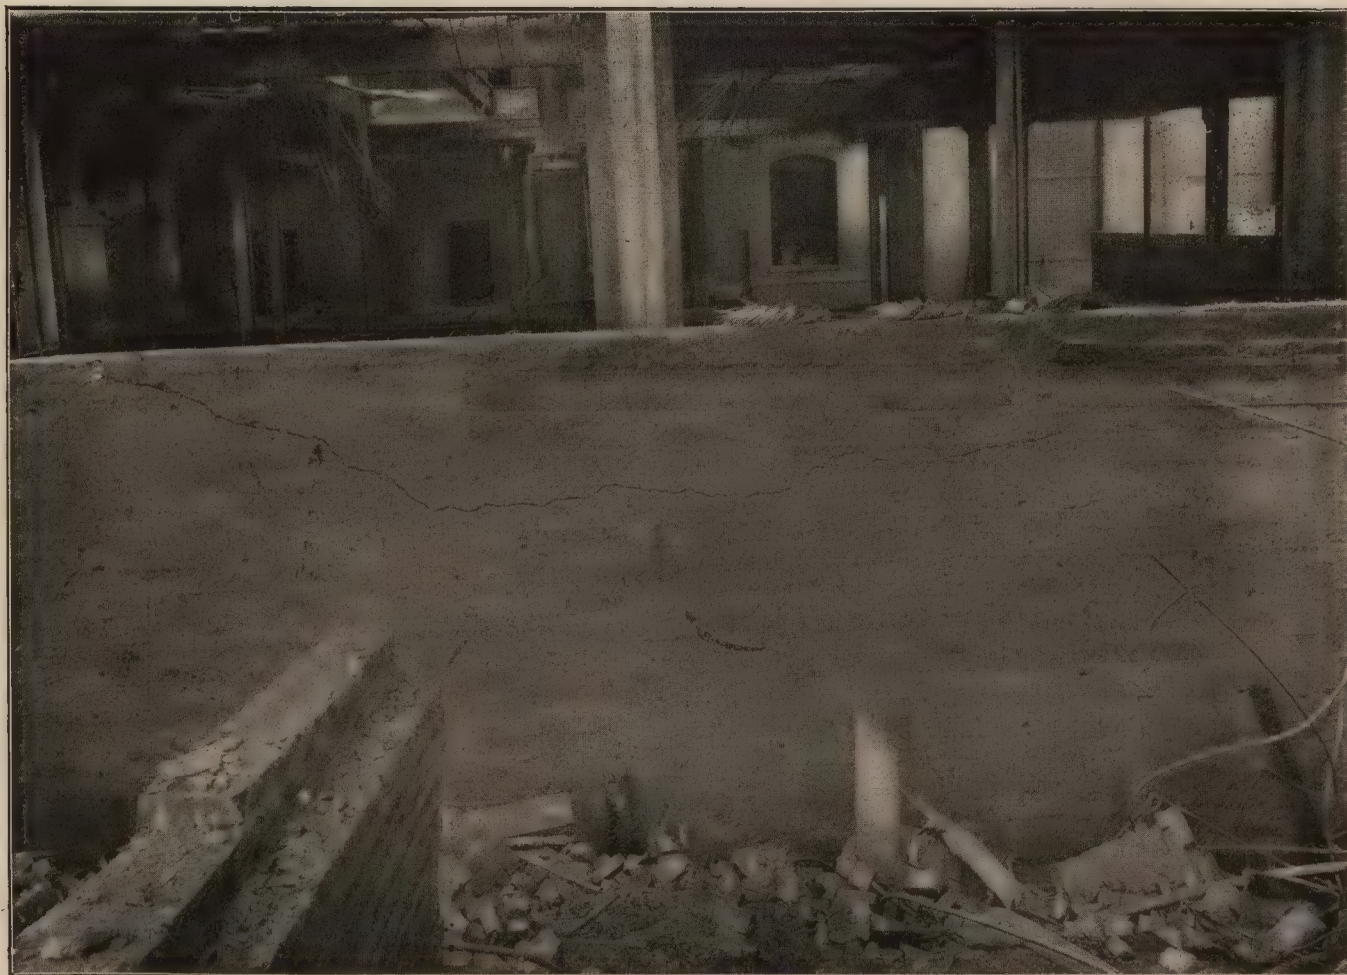
*St. Francis Hotel*

Showing earthquake crack in heavy concrete foundation in rear part of building;  
also destruction of concrete floors.

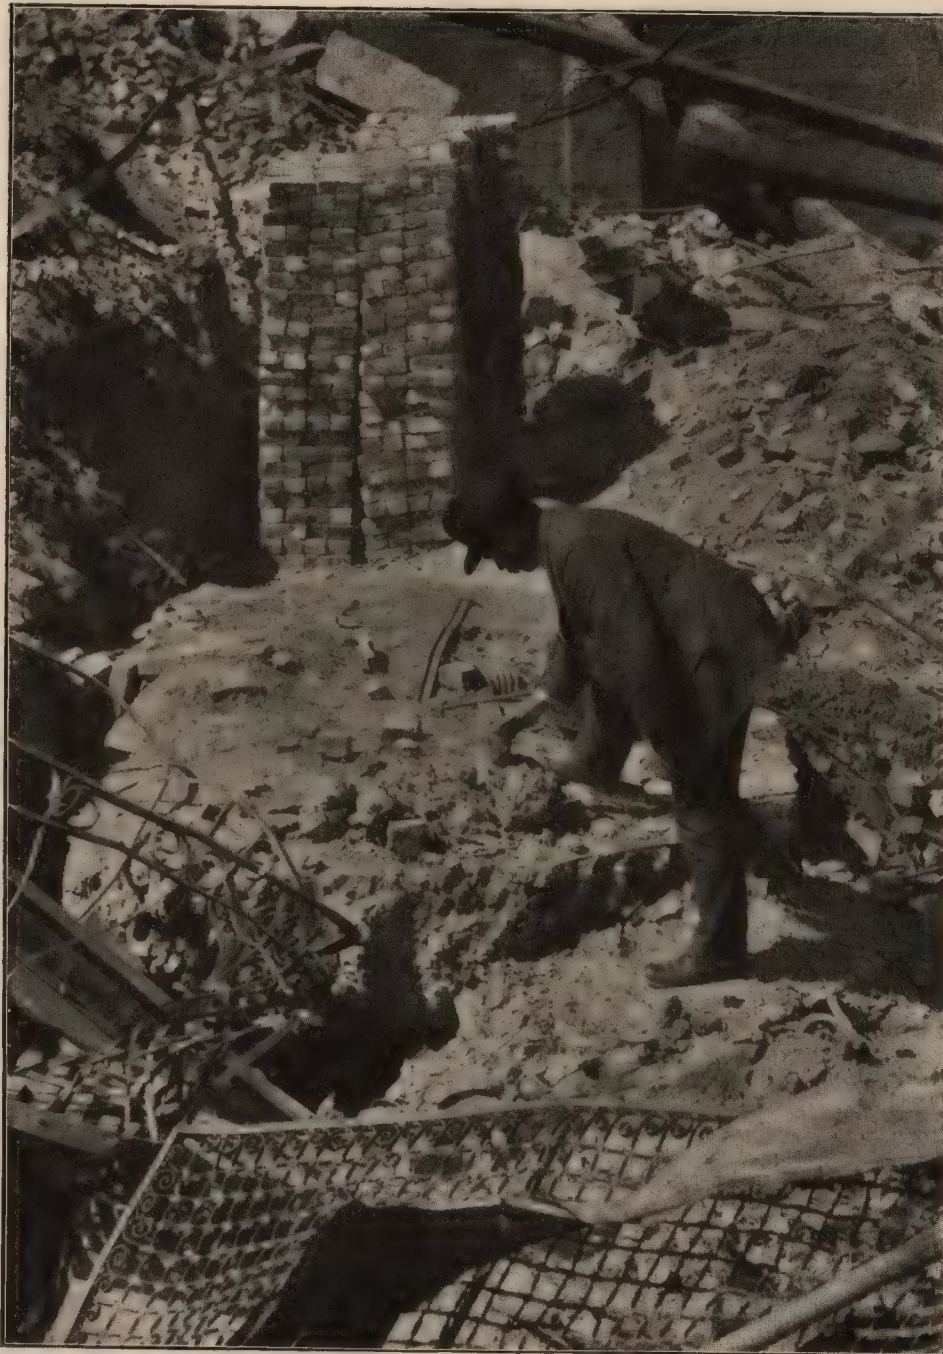
### *Chinese Bazaar Building*

Same as preceding picture. Showing basement where entire thickness of concrete wall was dehydrated, or burnt, by fire.
